Pothole Prevention and Innovative Repair

Department of Civil, Environmental, and Geo- Engineering
University of Minnesota

Research Project
Final Report 2018-14

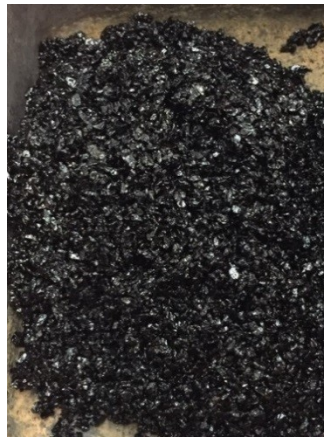
Figure 4.1: Pothole patching material.

These patching materials do not need any mixing preparation or application of tack coat and can be poured directly into the hole. Minimal or no equipment is required for placing and compacting and can be opened to traffic immediately after application. A typical pothole-patching material is shown in Figure 4.1.

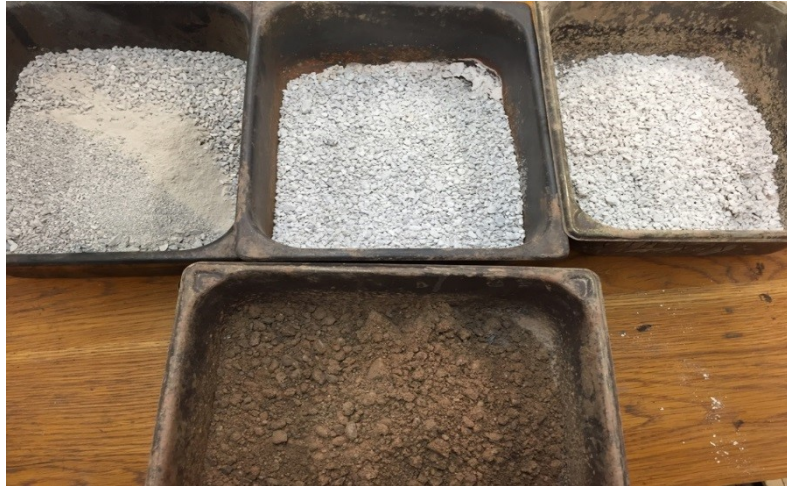
Figure 4.2: Aggregate residue from patching materials. Upper Left: Perma-Patch. Upper Middle: Summer Mix_UPM. Upper Right: Winter Mix_UPM. Bottom: Winter Mix_St Paul.

To obtain information about the aggregates contained in the patching materials, the materials were burnt in the ignition oven and a sieve analysis was performed. The aggregate residue for the patching materials are shown in Figure 4.2. The gradation curves are shown in Figure 4.3.

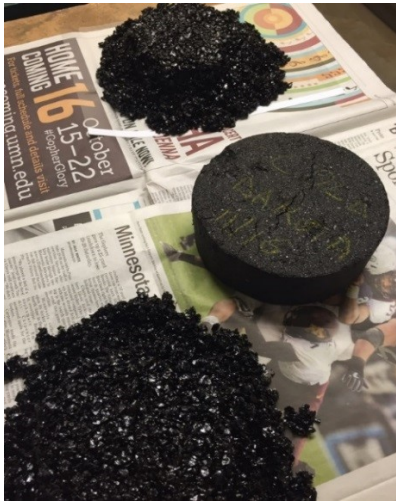
Figure 4.4: Sample preparation using gyratory compaction.

First, gyratory compaction was used. However, it was impossible to compact the patching materials at room temperature. Only the winter mix from St. Paul asphalt plant (WM_SP) “survived” the compaction; the other three collapsed right after extraction. An example is shown in Figure 4.4, in which the middle sample is the winter mix from the St. Paul asphalt plant.

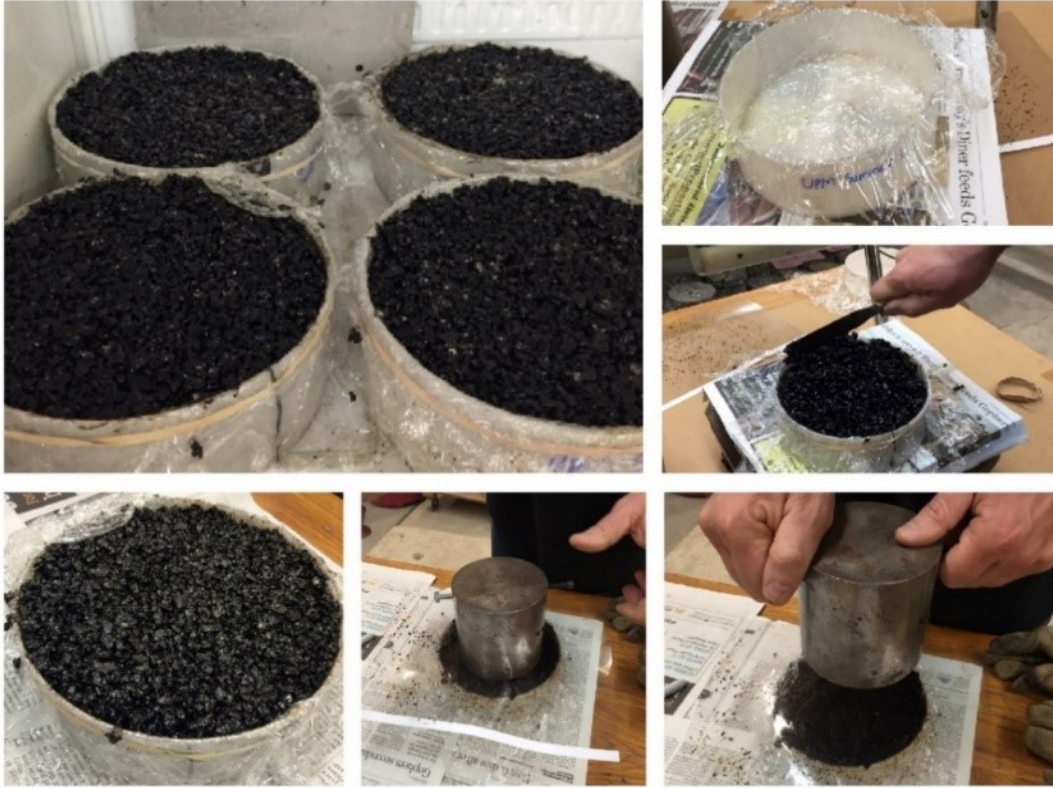
Figure 4.5: Sample preparation using plastic mold and manual compaction.

The sample preparation steps using plastic molds and manual compaction are shown in Figure 4.5.

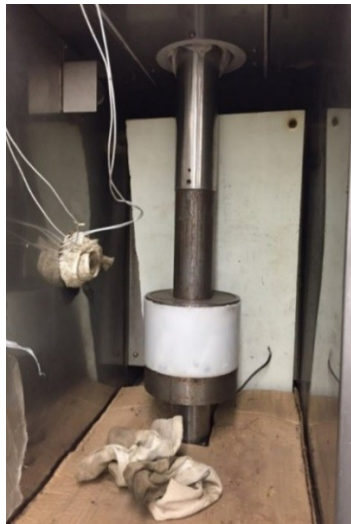
Figure 4.6: Sample preparation using plastic mold and MTS compaction.

Since this procedure is difficult and not repeatable, an MTS testing frame was used to simulate Marshall Compaction for repeatability (Figure 4.6). Several 100 compression cycles of a square wave between 0 and 20 kN at a frequency of 1 Hz were performed to each side of the mold. The setup is shown in Figure 4.6.

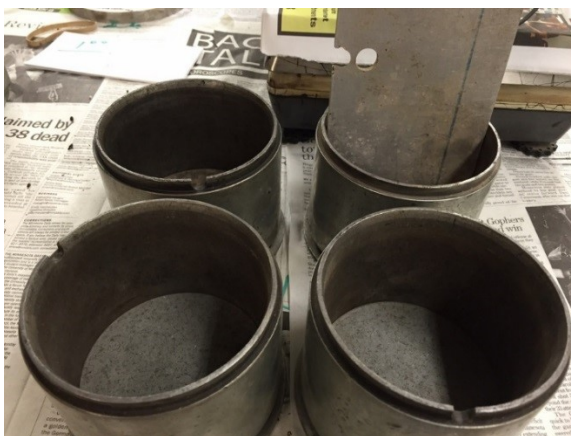
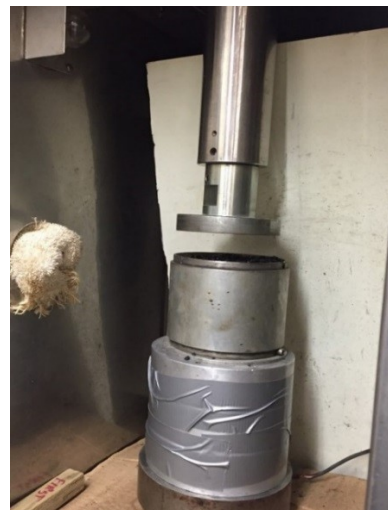
Figure 4.8: Sample preparation using steel mold and MTS compaction.

It was observed that the plastic mold bulged significantly during compaction and affected the geometry of specimen. To address this issue, steel molds were used to prepare samples using MTS compaction, as shown in Figure 4.8. This method was used for further testing, as described next.

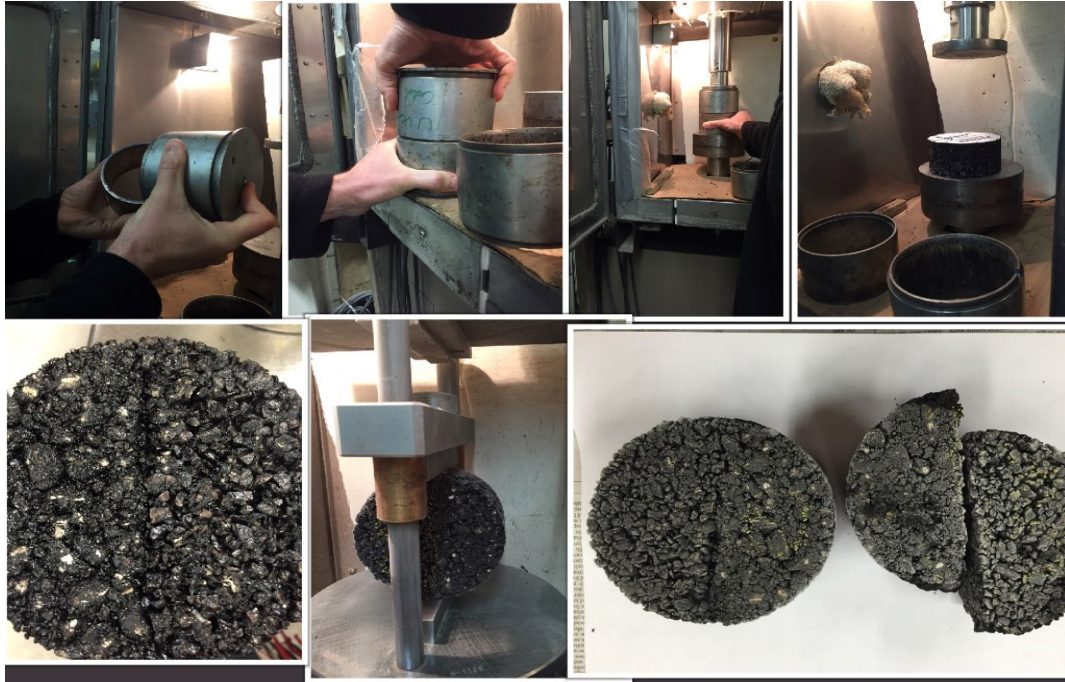
Figure 4.12: Additional photos of sample preparation and testing with half HMA and half patching material.

Photos of various stages of sample preparation are shown in Figure 4.11 and Figure 4.12

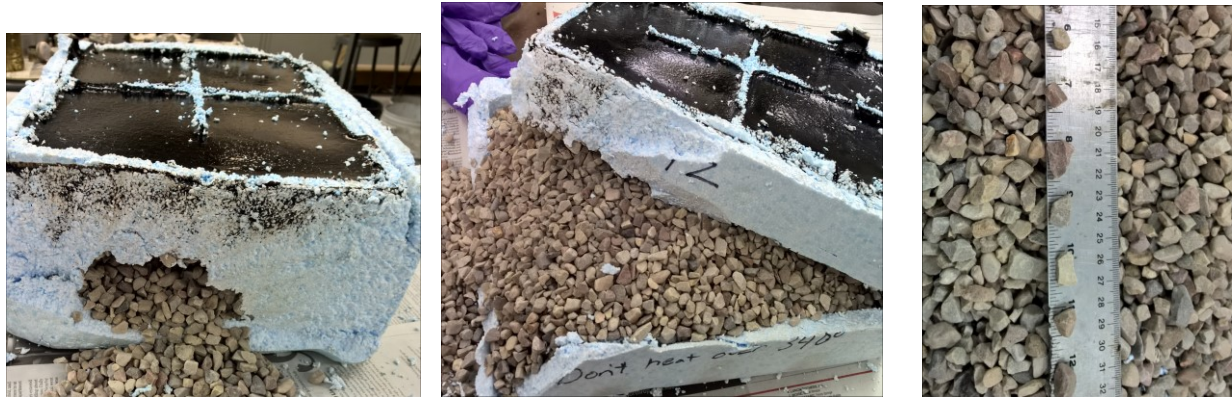
Figure 4.15: GAP Materials

A fifth patching material was received (Figure 4.15) by the research team and a similar experimental investigation was performed. According to the manufacturer, GAP Mastic is a hot-applied, polymer modified asphalt mixed with engineered aggregates and modifiers designed to fill wide cracks and defects, to prevent water infiltration, and restore ride quality. It is formulated with a low viscosity for ease of installation and enhanced crack penetration. This material is extremely flexible, which enables it to perform exceptionally well in cold weather, yet also has a high softening point so it will not track or rut with traffic. GAP material is designed as a permanent repair solution for wide thermal cracks, fatigue cracking, rutting, and depressed, broken-up areas.

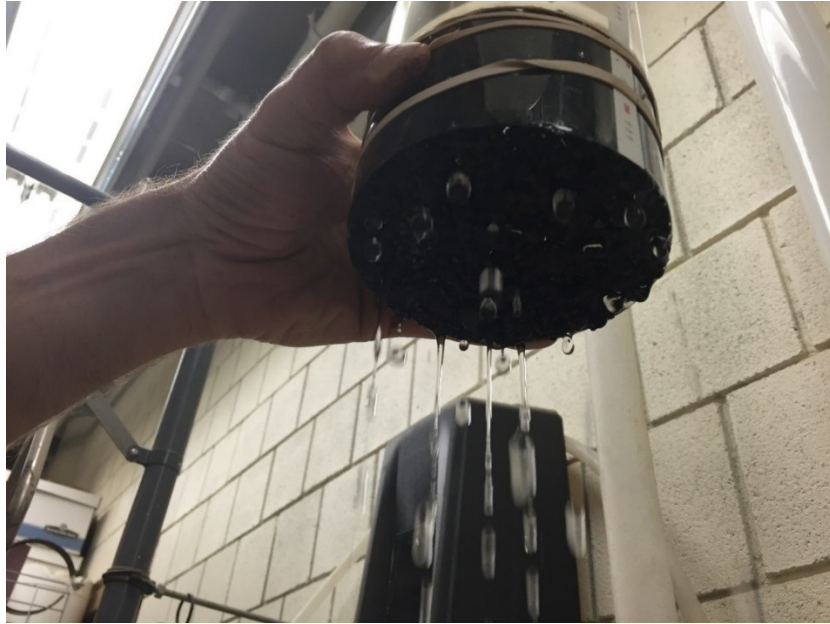
Figure 4.19: Test Setup for Water Penetration Tests.
